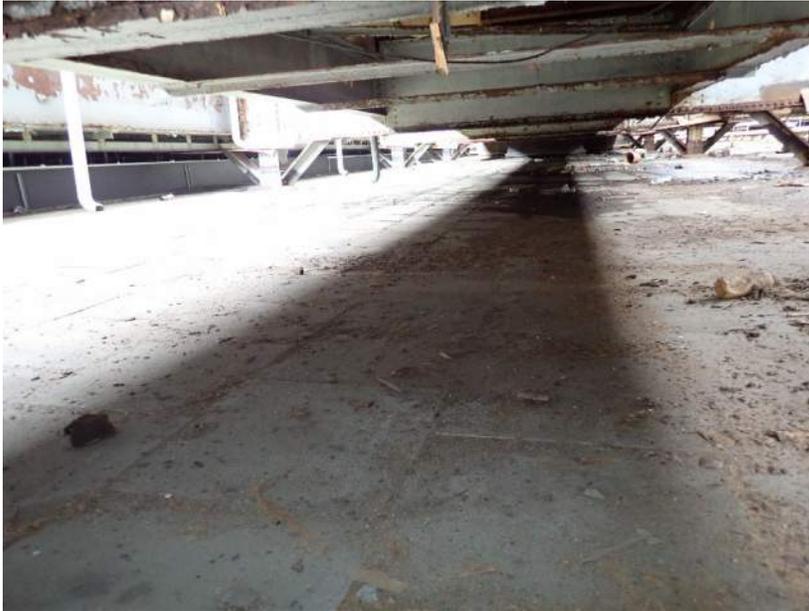
Photo 1

Overview of existing roof below the tracks.

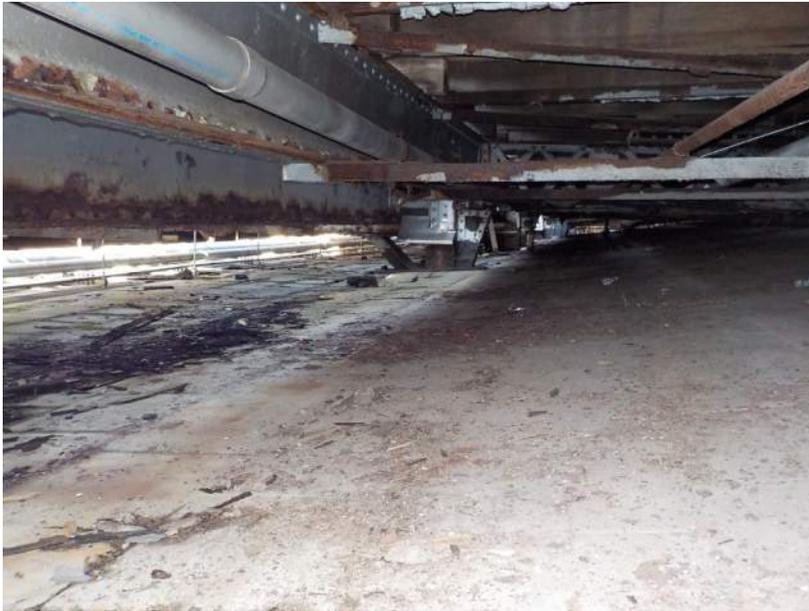
Photo 2

Overview of existing roof below the tracks.

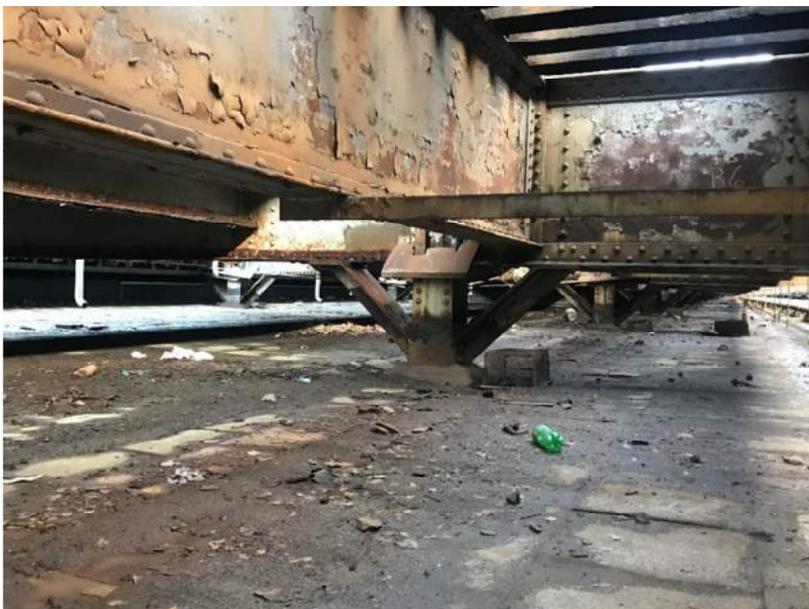
Photo 3

Overview of existing roof below the tracks.

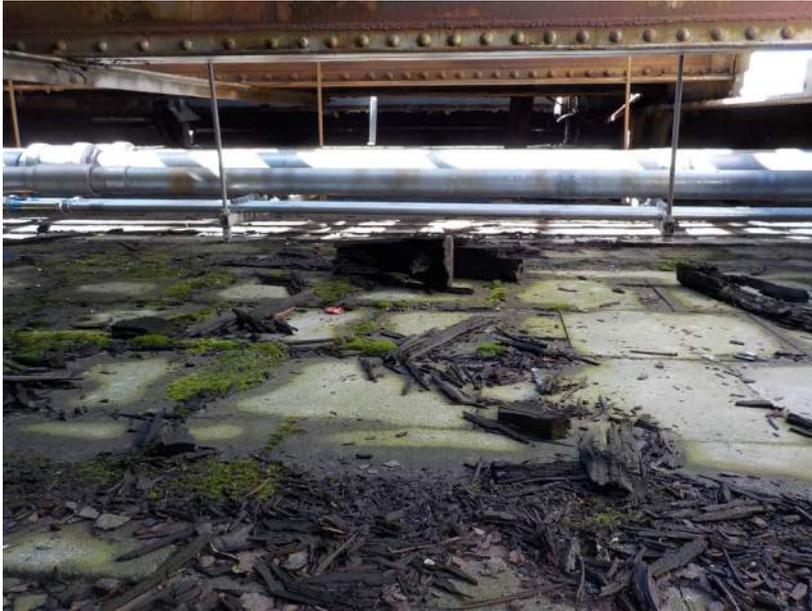
Photo 4

Overview of existing roof below the tracks.

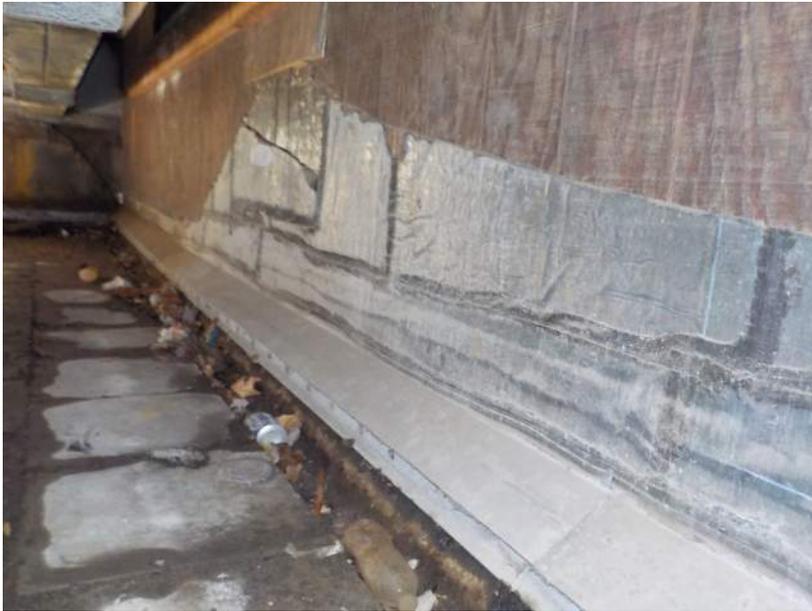
Photo 5

Rising wall at penthouse providing access to the platform above the roof.

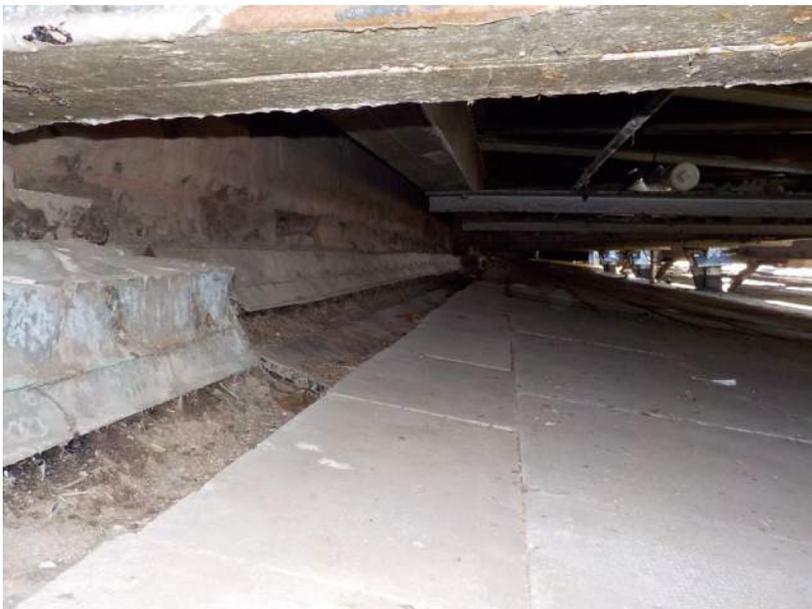
Photo 6

Rising masonry building wall at the east side of the roof.

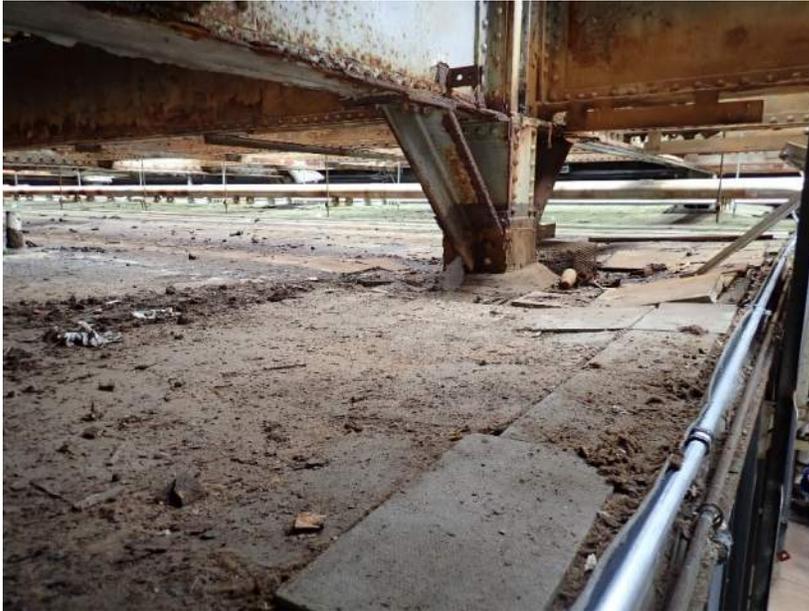
Photo 7

Existing edge condition at the south side of the roof below the tracks. Condition at north side is similar.

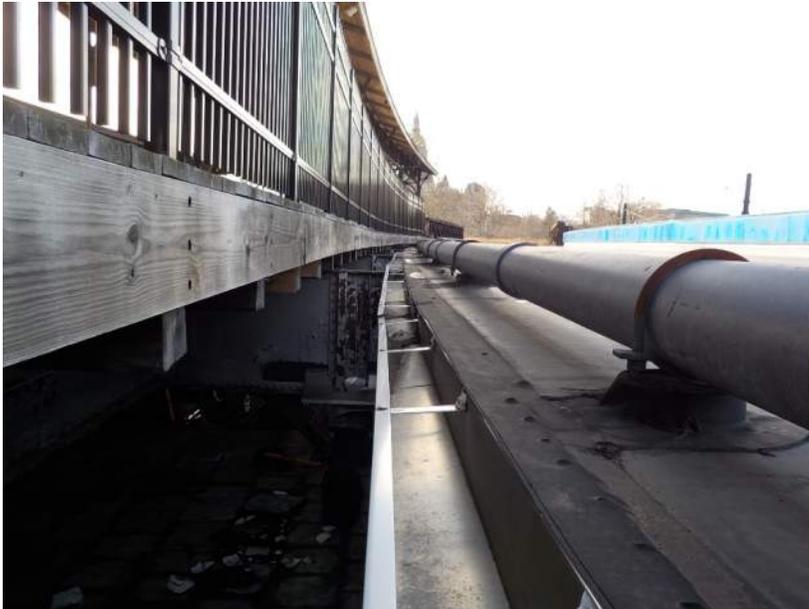
Photo 8

Existing construction to remain above the west side of the roof below the track (left side of photo is active platform, right side of photo is the canopy above the bus terminal – not in contract)

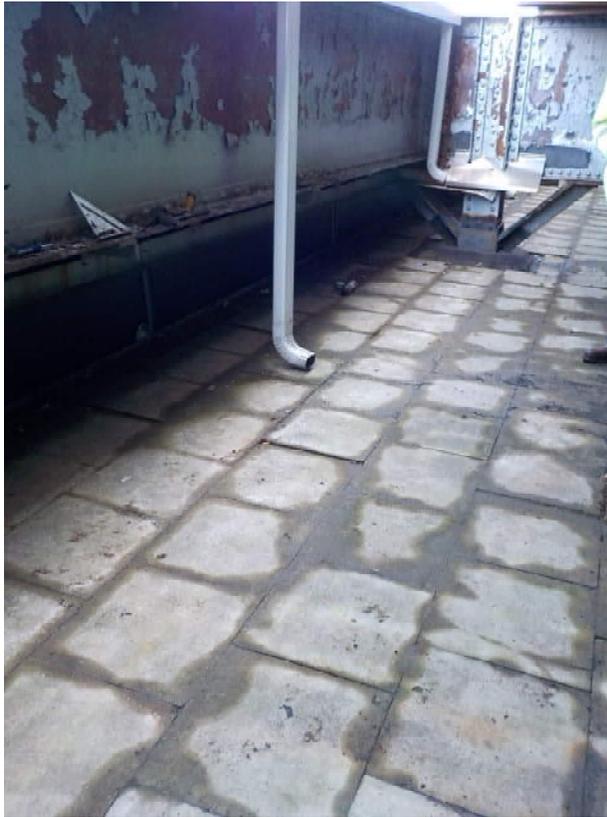
Photo 9

Overview of the west side of the roof below the tracks.

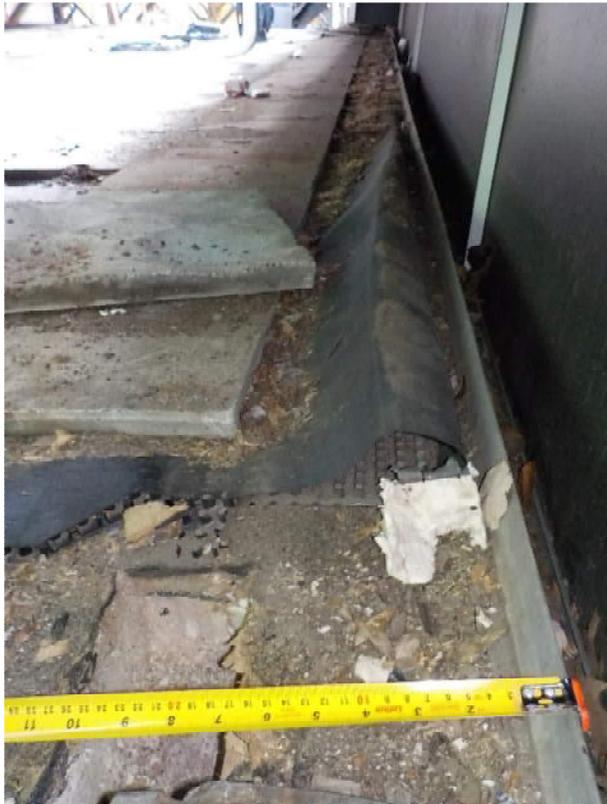
Photo 10

Existing edge condition at the west side of the roof below the tracks.

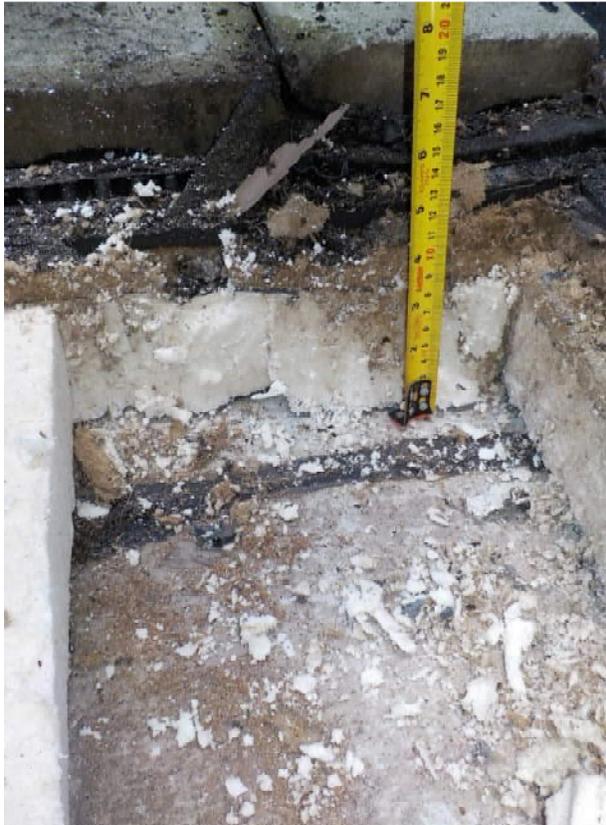
Photo 11

Exploratory cut in existing roofing system at the roof below the track.

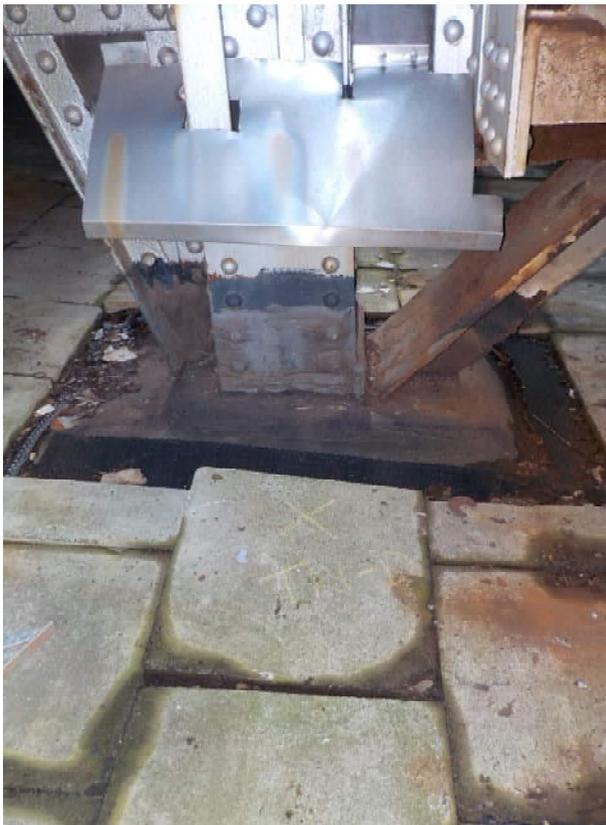
Photo 12

Typical steel column penetration.

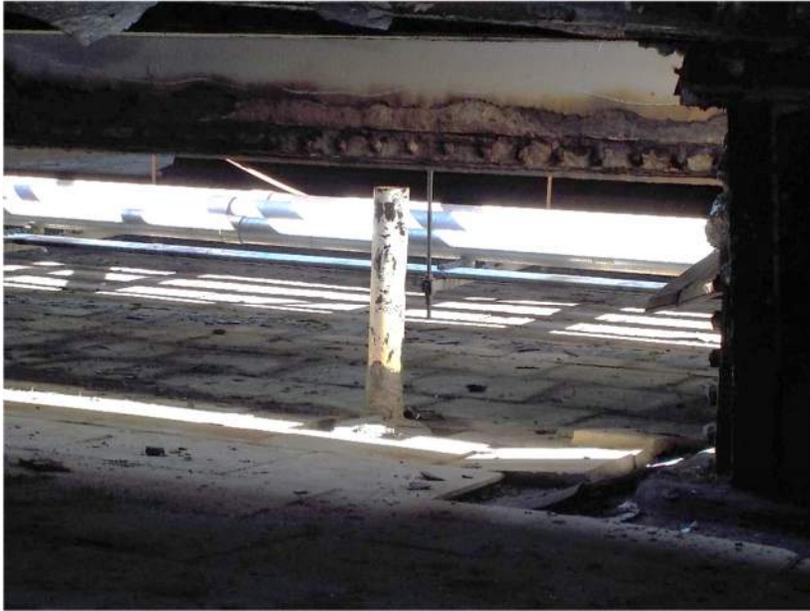
Photo 13

Vent pipe penetration through the roof below the tracks.

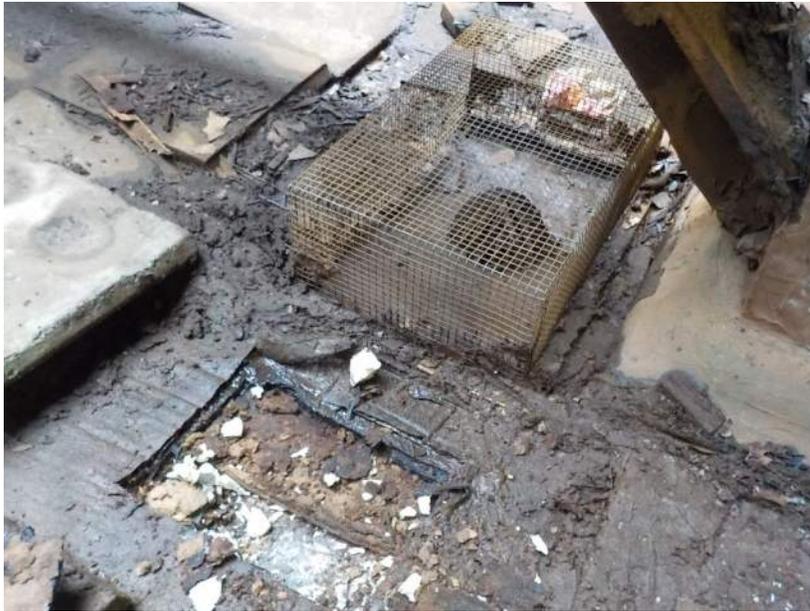
Photo 14

Typical roof drain with metal screen cover adjacent to column at the roof below the tracks. Note the exploratory opening visible in the photo adjacent to the roof drain.
